Strengthening Water Quality Monitoring to Prevent and Respond to Cholera Outbreaks

GTFCC WASH Working Group Meeting: March 2023

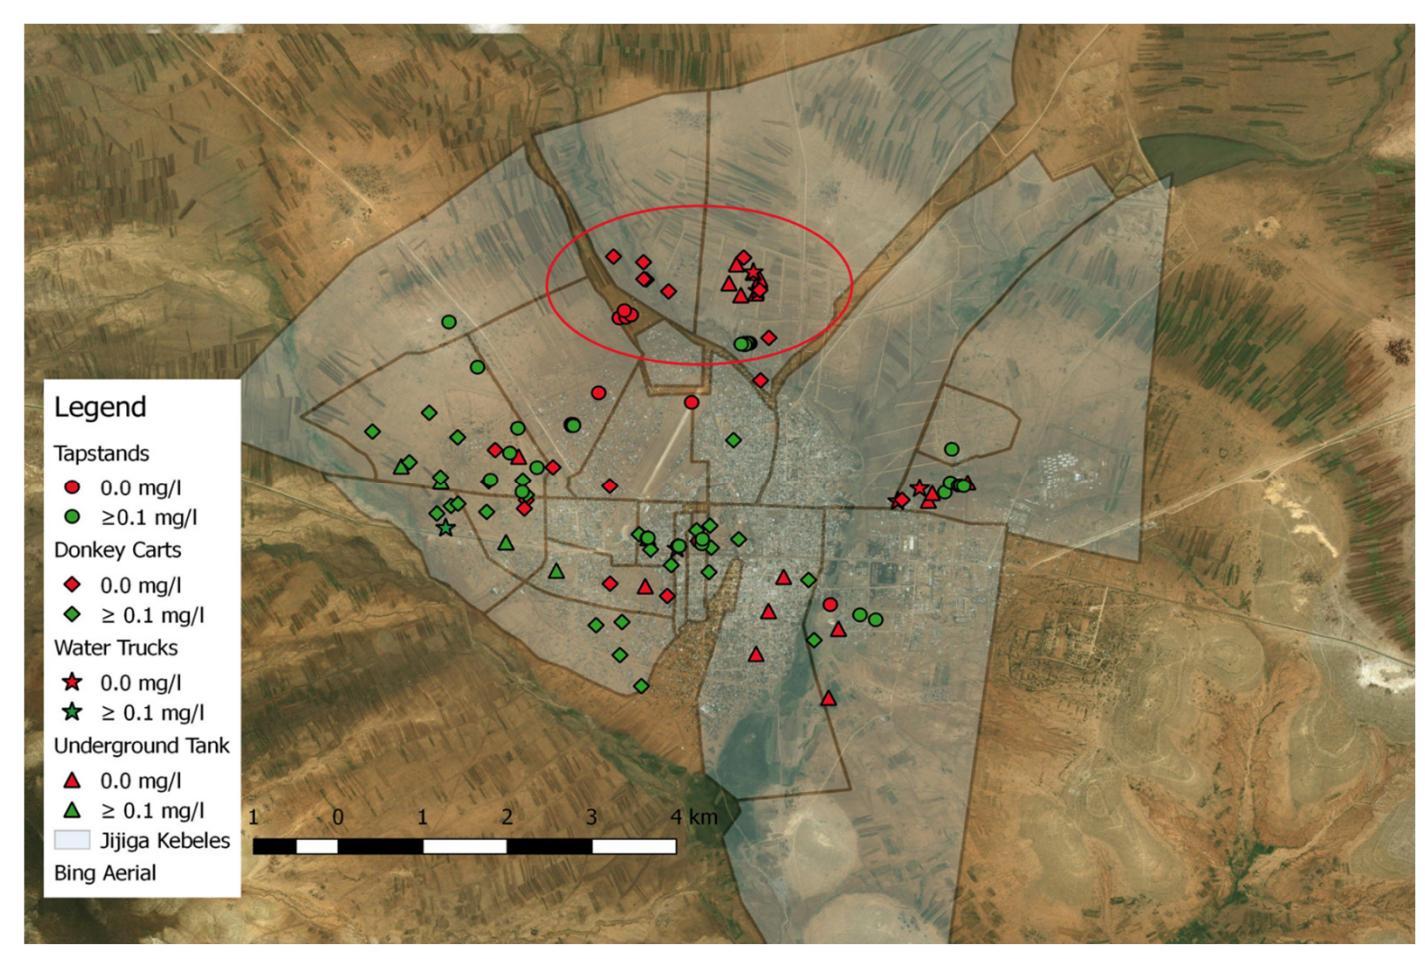
Water Quality Rapid Assessment Results – Jijiga

- Spatial distribution of FRC data collected during assessment
- Data used to find 5 additional donkey cart filling stations in the north of Jijiga within the red circle.
- Decentralized chlorination was implemented at these points.
- Next Step: Created a monitoring system to regularly monitor FRC levels at targeted points

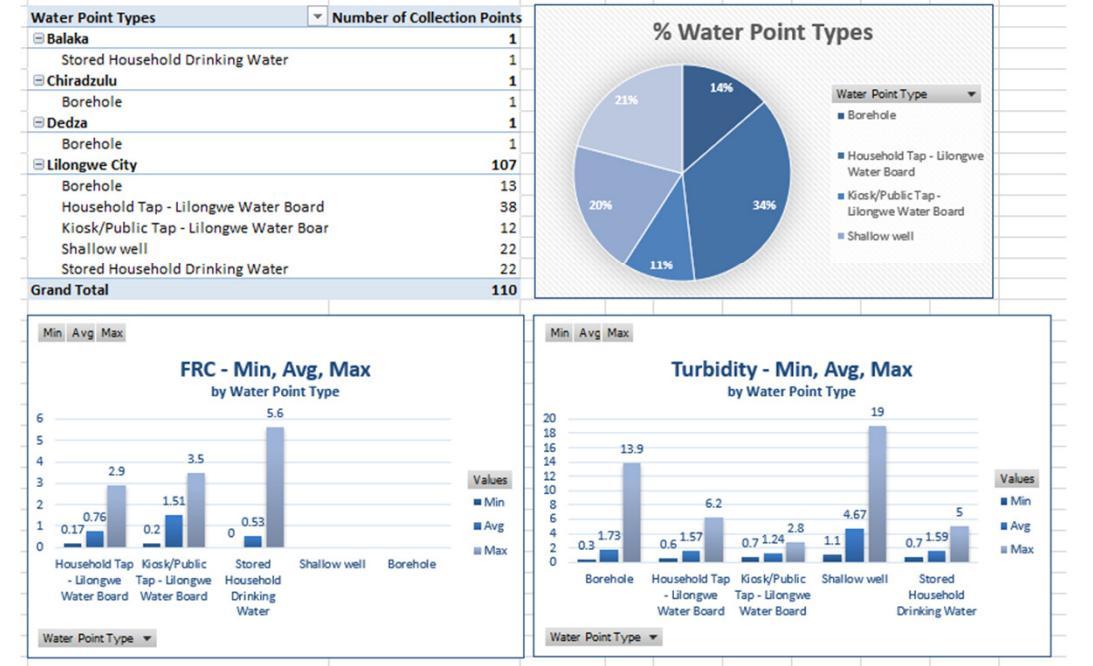
Water Quality Rapid Assessment Results – Lilongwe, Malawi

- Created Excel dashboard that can be updated with using Kobo Collect Query
- 50/50 piped water taps tested for chlorine had detectable FRC

- 19/21 shallow wells sampled > 100 cfu/100ml for fecal coliforms
- 3/10 boreholes sampled > 100 cfu/100ml for fecal coliforms
- Data shared with WASH implementing partners on the importance of chlorination of alternative water sources

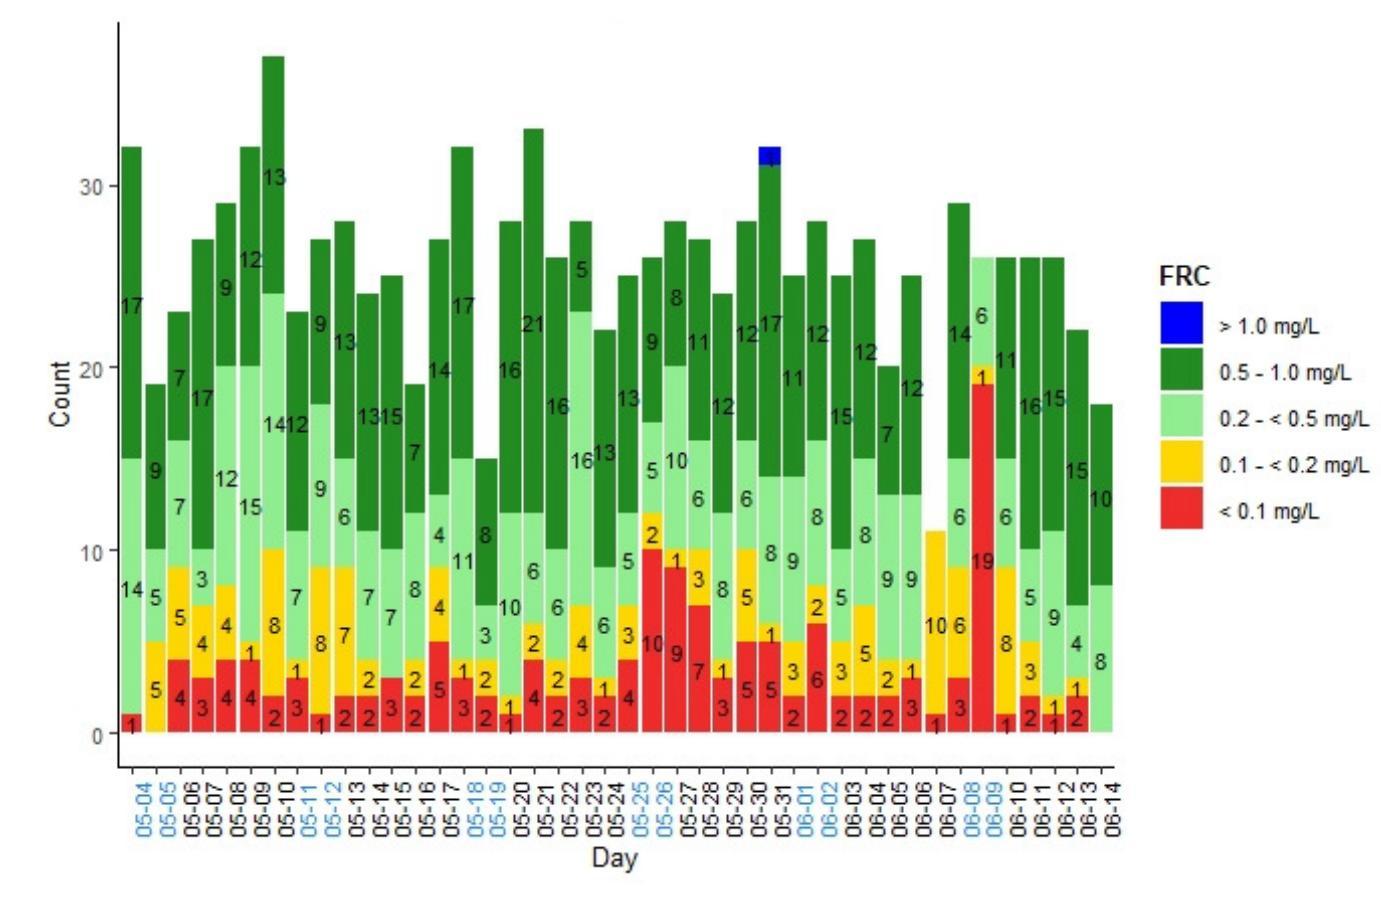
Beira and Dondo - Piped Network Results

Daily FRC levels

- Shows the daily fluctuations of number of readings and FRC levels
 - Some weekend days larger number of readings at 0 mg/L
 - Staffing shortages

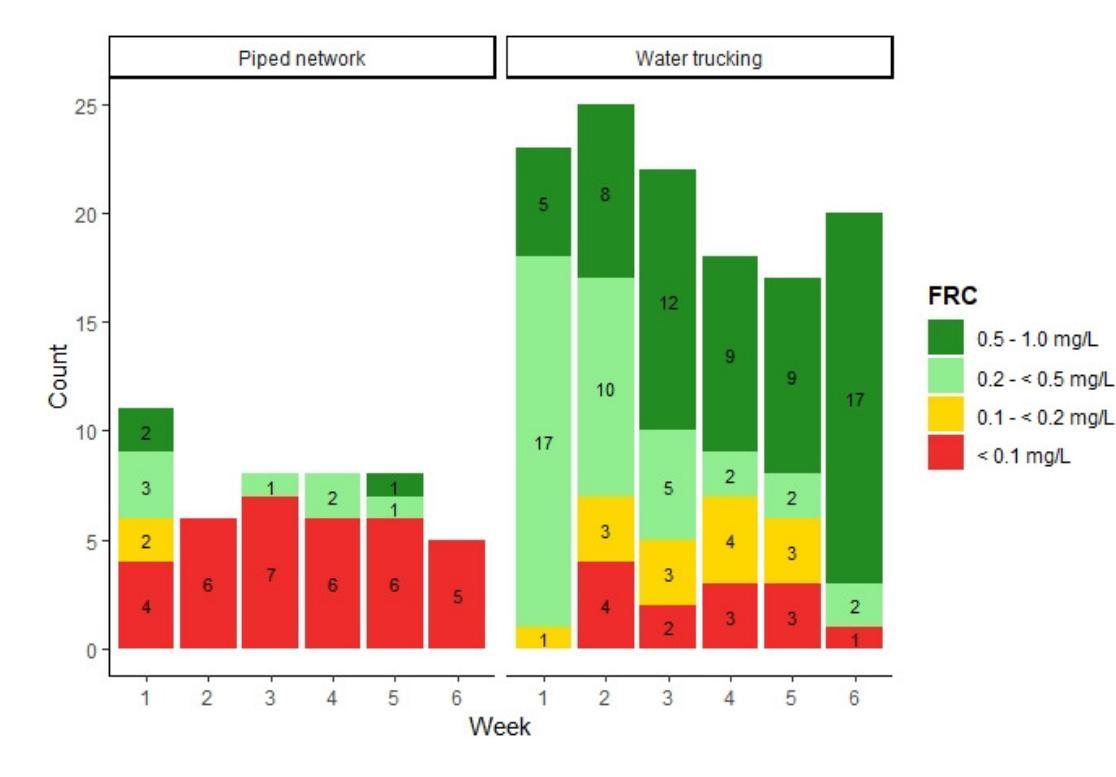
Beira and Dondo- Accommodation Center Results

- 131 samples from bladders or tanks filled by water trucks
- The quality of water delivered by truck was better and improved over time
- 47 from samples from new piped network connections
- FRC from samples from the piped network points remained low
 - New connections further away from distribution centers
- 26% of piped water samples had detectable FRC versus 90% from trucked water samples

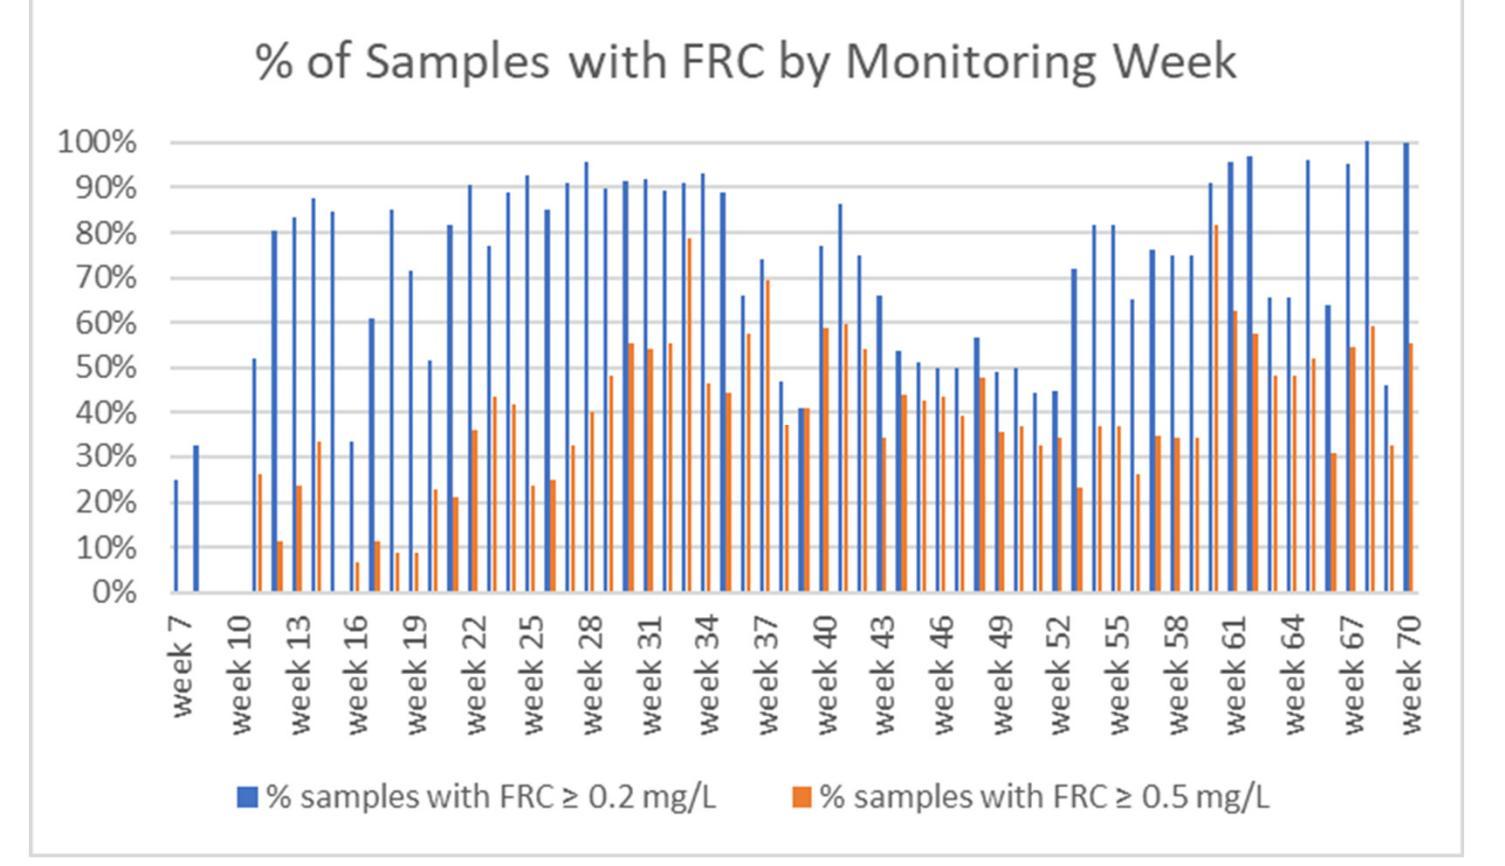
Zanzibar Piped Network Results

- Took ~7 weeks to start monitoring in the 5 districts
- First, increased the number of samples with FRC ≥ 0.2 mg/L in the system
- Next, worked to increase number of samples with FRC ≥ 0.5 mg/L
